# TEST REPORT

Task Number #163782

Sample Sample 3 MK677

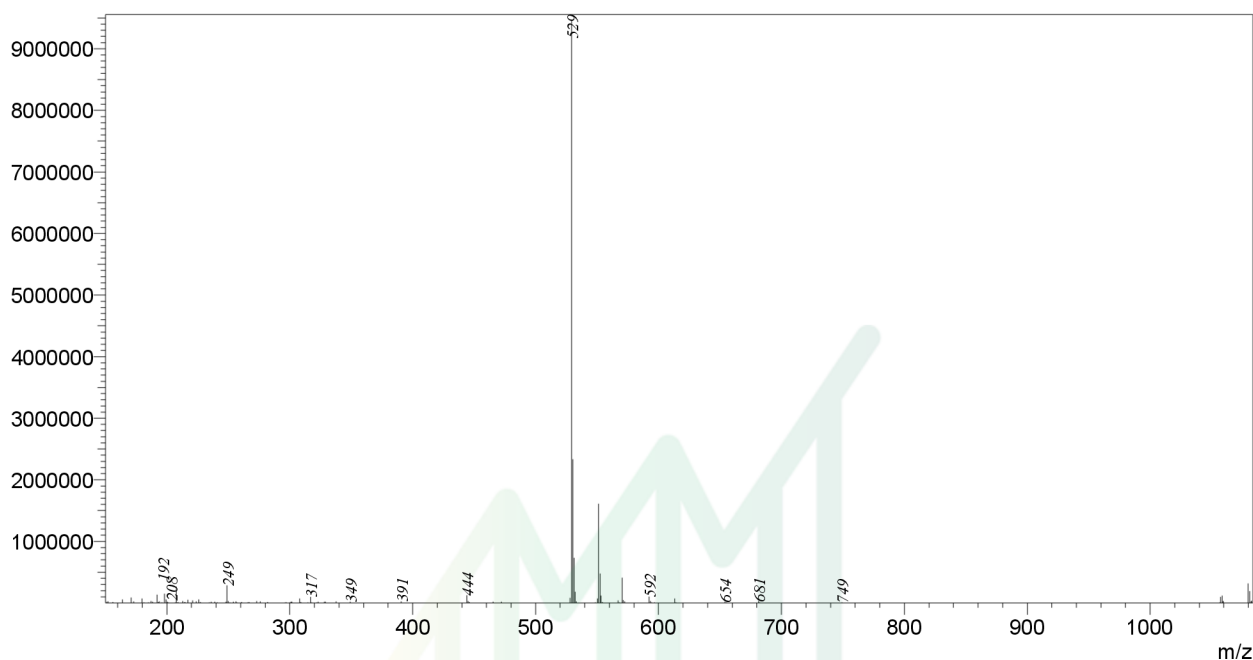
Line#:1 R.Time:1.475(Scan#:687)  
MassPeaks:106  
RawMode:Single 1.475(687) BasePeak:529(9461444)  
BG Mode:None Segment 1 - Event 1

LCMS analysis identified the presence of MK-677 (ibutamoren HCl salt), and degradation products. LCMS spectra are attached. No significant contamination detected.

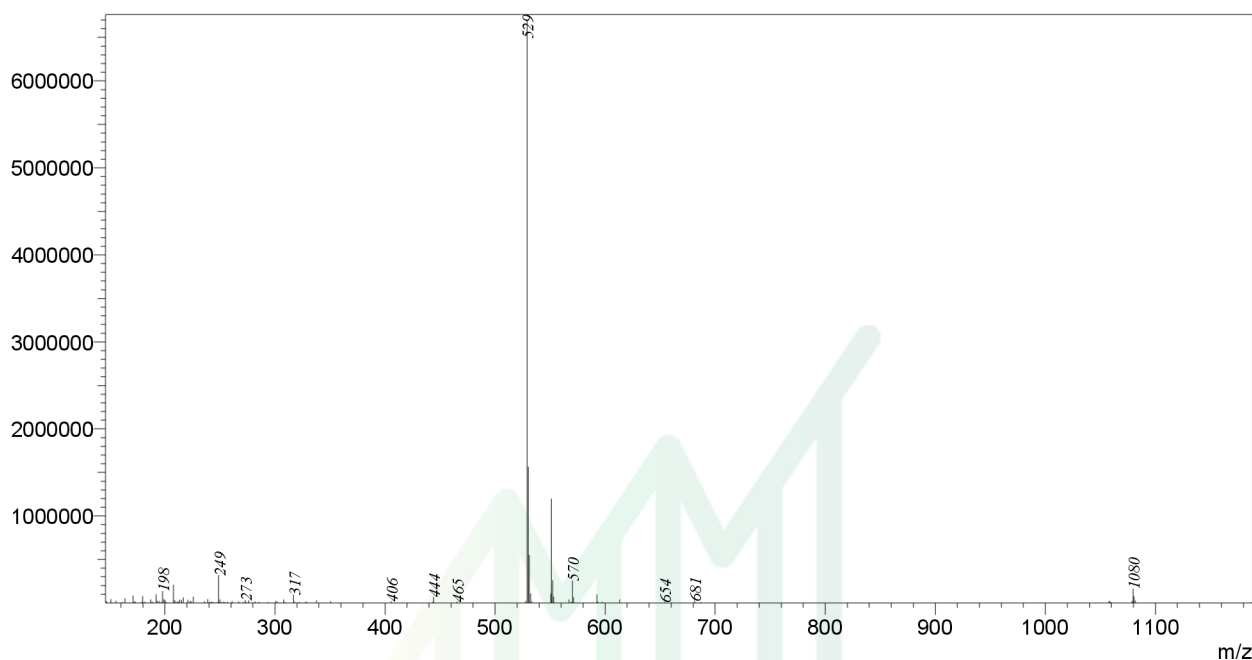
Line#:1 R.Time:1.486(Scan#:692)  
MassPeaks:99  
RawMode:Single 1.486(692) BasePeak:529(6696033)  
BG Mode:None Segment 1 - Event 1
